UNITED STATES DISTRICT COURT SOUTHERN DISTRICT OF OHIO

CASE NO. C-1-02-107

REQUEST FOR REVIEW

Metropolitan Sewer District of Greater Cincinnati **Wastewater Collection Division Project Tracking Form**

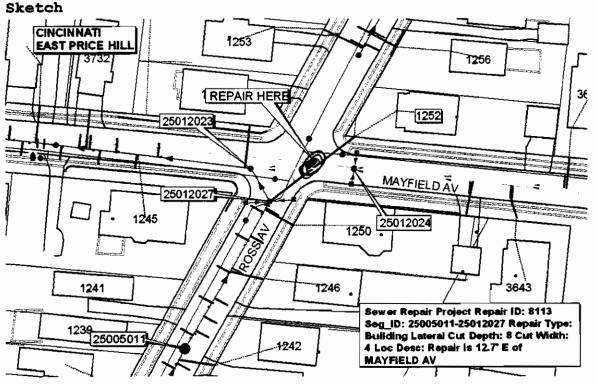
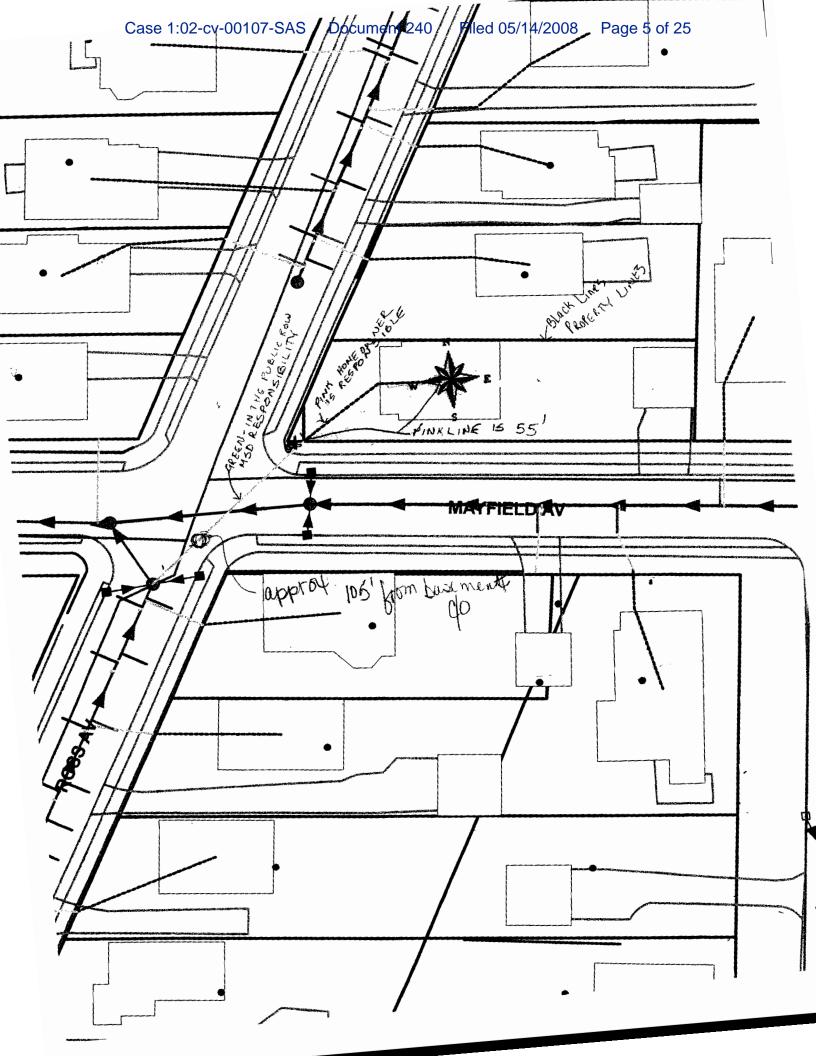
Project No. 00682-08

EMERG. TAP REPAIR, WIB, TV CREW LOCATED BLOCKAGE IN R-O-W. THE TAP RUNS FROM 1252 ROSS AV INTO MH 25012027. UPON EXCAVTION TV UP AND DNSTM ON TAP FOR CONDITION IN R-O-W. THE LATERAL BYPASSES A 12" SEWER THAT RUNS FROM 25012024-25012023. IT MAY BE POSSIBLE TO TIE INTO THE 12" SEWER LINE AND FSA THE DS SECTION OF THE LATERAL, IF THIS OPTION IS CHOSEN MAKE NOTE THAT THE 12" SEWER IS LINED.Crew replaced 19' of 6" h/tand installed 2-way c/o
